<b>Manufacturer:</b>	PDQ Yachts
<b>Model:</b>	Capella
<b>Model Year:</b>	2002
<b>Hull No.:</b>	QPQ36091G102
<b>Registration or License Number:</b>	ON836469
<b>Port of Registry:</b>	Ontario
<b>Registered Tonnage:</b>	Not calculated
<b>Length:</b>	36 feet 5 inches
<b>Beam:</b>	18 feet 3 inches
<b>Draft:</b>	2 feet 11 inches

## 18. Summary of Inspection

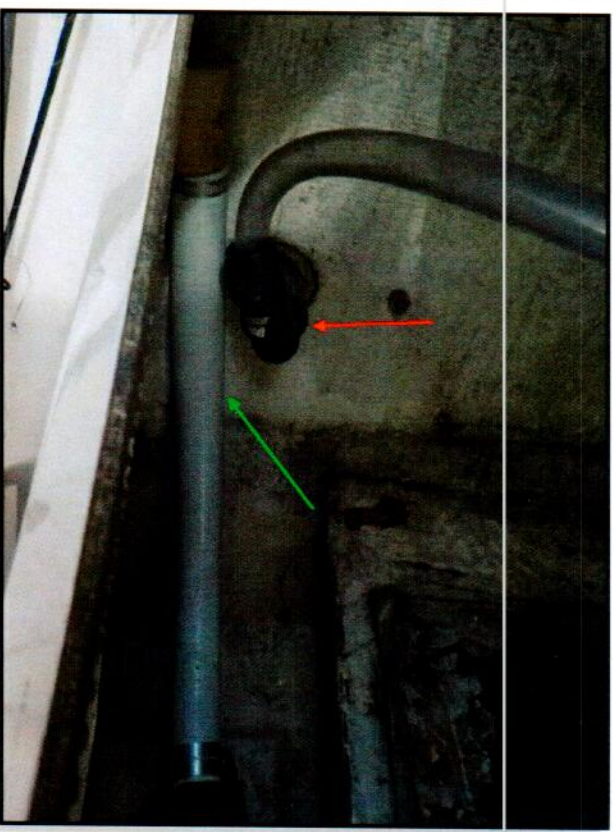
**DSCN0525**

| 1. Two of the through hull fittings aft of the shower were found with the discharge hoses cut. The larger of the two was fit with a wood plug. The smaller hose was left open. | 1. If both through hull fittings are no longer in use both hoses should be removed and Marelon plugs or caps secured in the inlets of both sea cocks. |

The red arrows point to the overboard discharge for the generator which has been disconnected and left with an open 90 degree elbow. This through hull fitting should be plugged or capped off. The same applies to the hose indicated by the green arrow

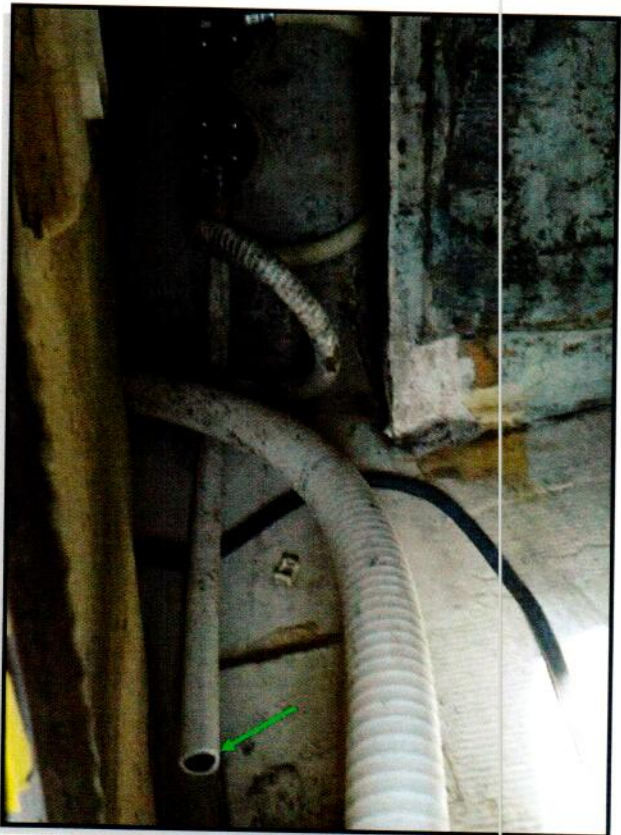
**DSCN0508**  
The arrow points to another through hull fitting that is no longer in use, it should be plugged or capped off.

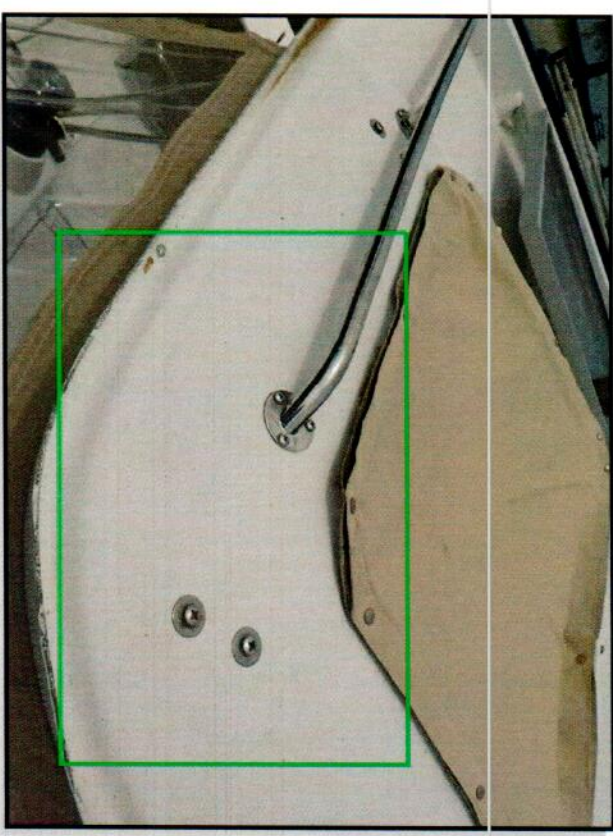
7. Moisture readings taken of the main decks, coach roof , hard top and aft cockpit found high levels of moisture to the following areas:
- A- the port and starboard fore decks between the forward deck cleat and the anchor rollers.
  - B- the port and starboard corners of the hardtop.
  - C- forward of the helm seat pedestal base.
  - D- the port and starboard side decks.

**DSCN0517**  
This area of the hardtop was found with high levels of moisture

Percussion soundings taken of these areas found early stages of core deterioration developing in the port and starboard fore decks directly aft of the anchor rollers. All other areas appear sound at present. It would be in the boat owner's best interest to reseal the deck hardware in and around the area outlined with high levels of moisture in an attempt to prevent any further ingress of moisture. PLEASE NOTE: this is only a temporary method of repair, eventually deck core deterioration will develop, requiring structural and cosmetic repair.

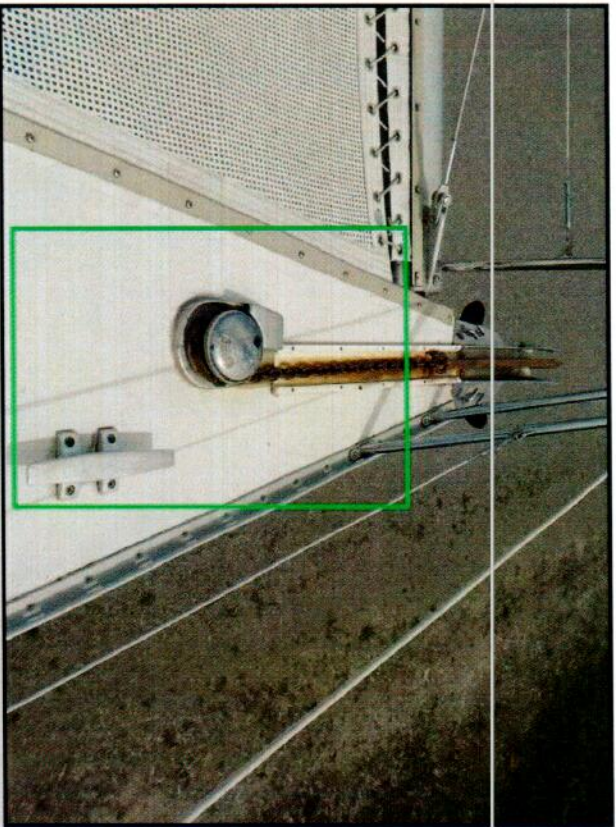
**DSCN0518**

This area of the port fore deck was found with high levels of moisture.

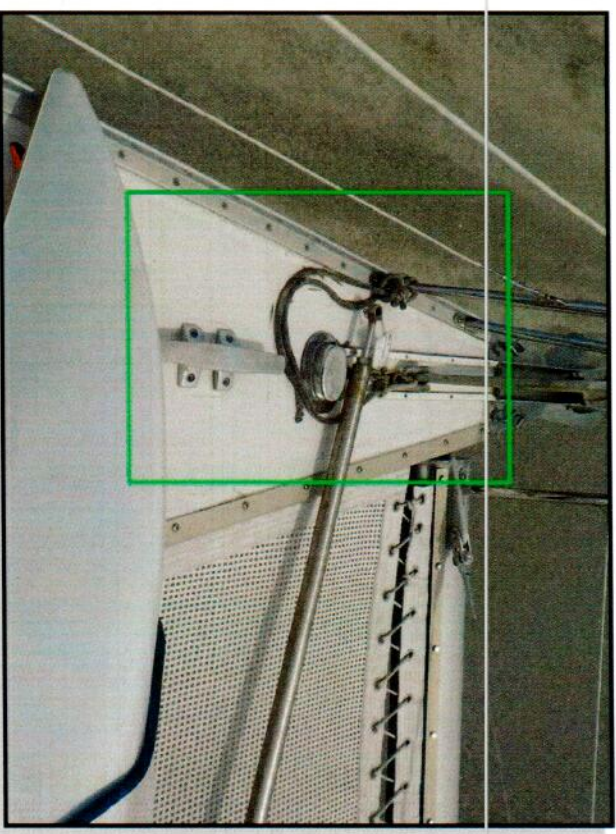
**DSCN0519**

This area of the starboard side deck was found with high levels of moisture

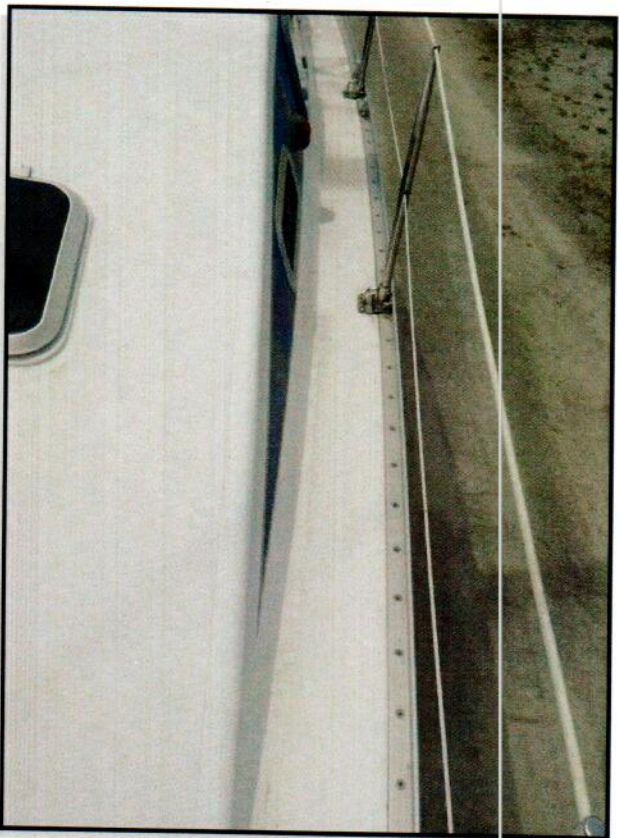
**DSCN0520**  
Port side deck found with high levels of moisture.

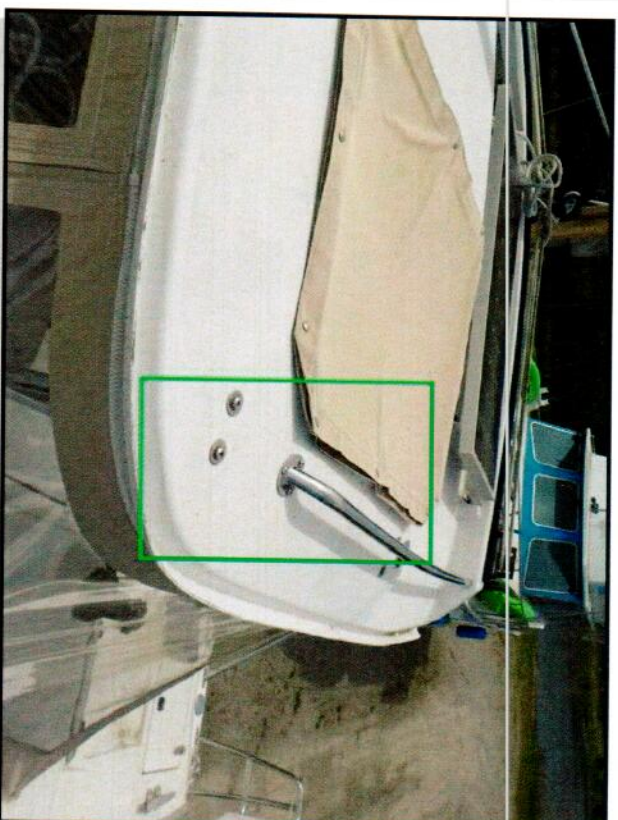
**DSCN0521**  
This area of the hardtop was found with high levels of moisture.
